On the mechanical integrity of retrieved dental implants

K. Shemtov-Yona, D. Rittel

To appear in: *Journal of the Mechanical Behavior of Biomedical Materials*

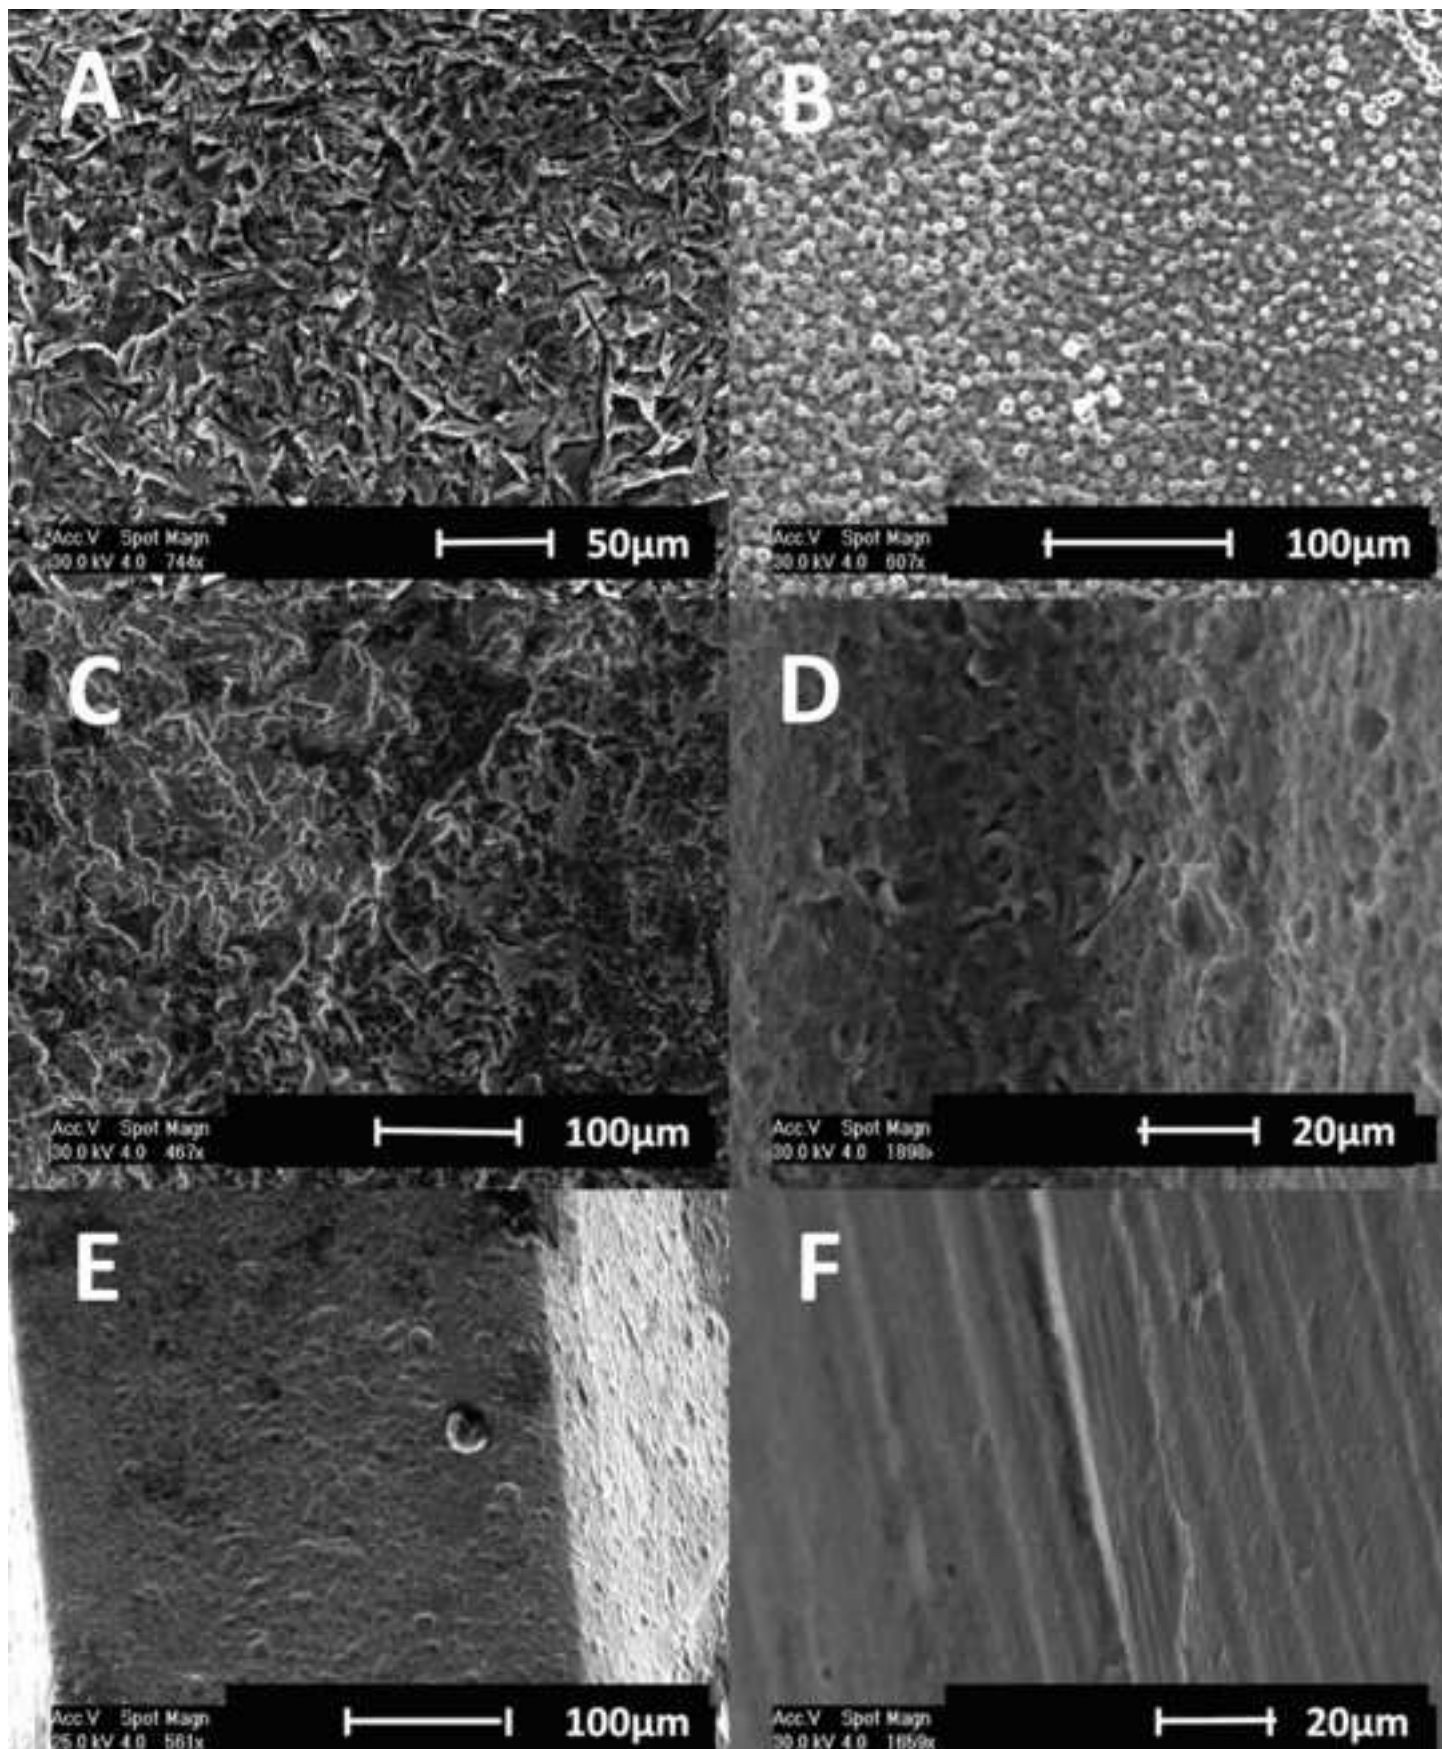
Next, the surface treatments were identified. It was found that 94% of the implants underwent a specific surface treatment, while the remaining 6% of the implants were as-machined only<sup>22</sup>. The surface treatments were further divided into two groups. The first, coated implants, includes titanium plasma spray (TPS) (30%), or anodizing (1%) The second comprises uncoated implants that underwent grit-blasting and etching (50%), grit blasting only (9%), or etching only (4%). Fig. 1 shows representative SEM micrographs of the 6 typical surface topographies.

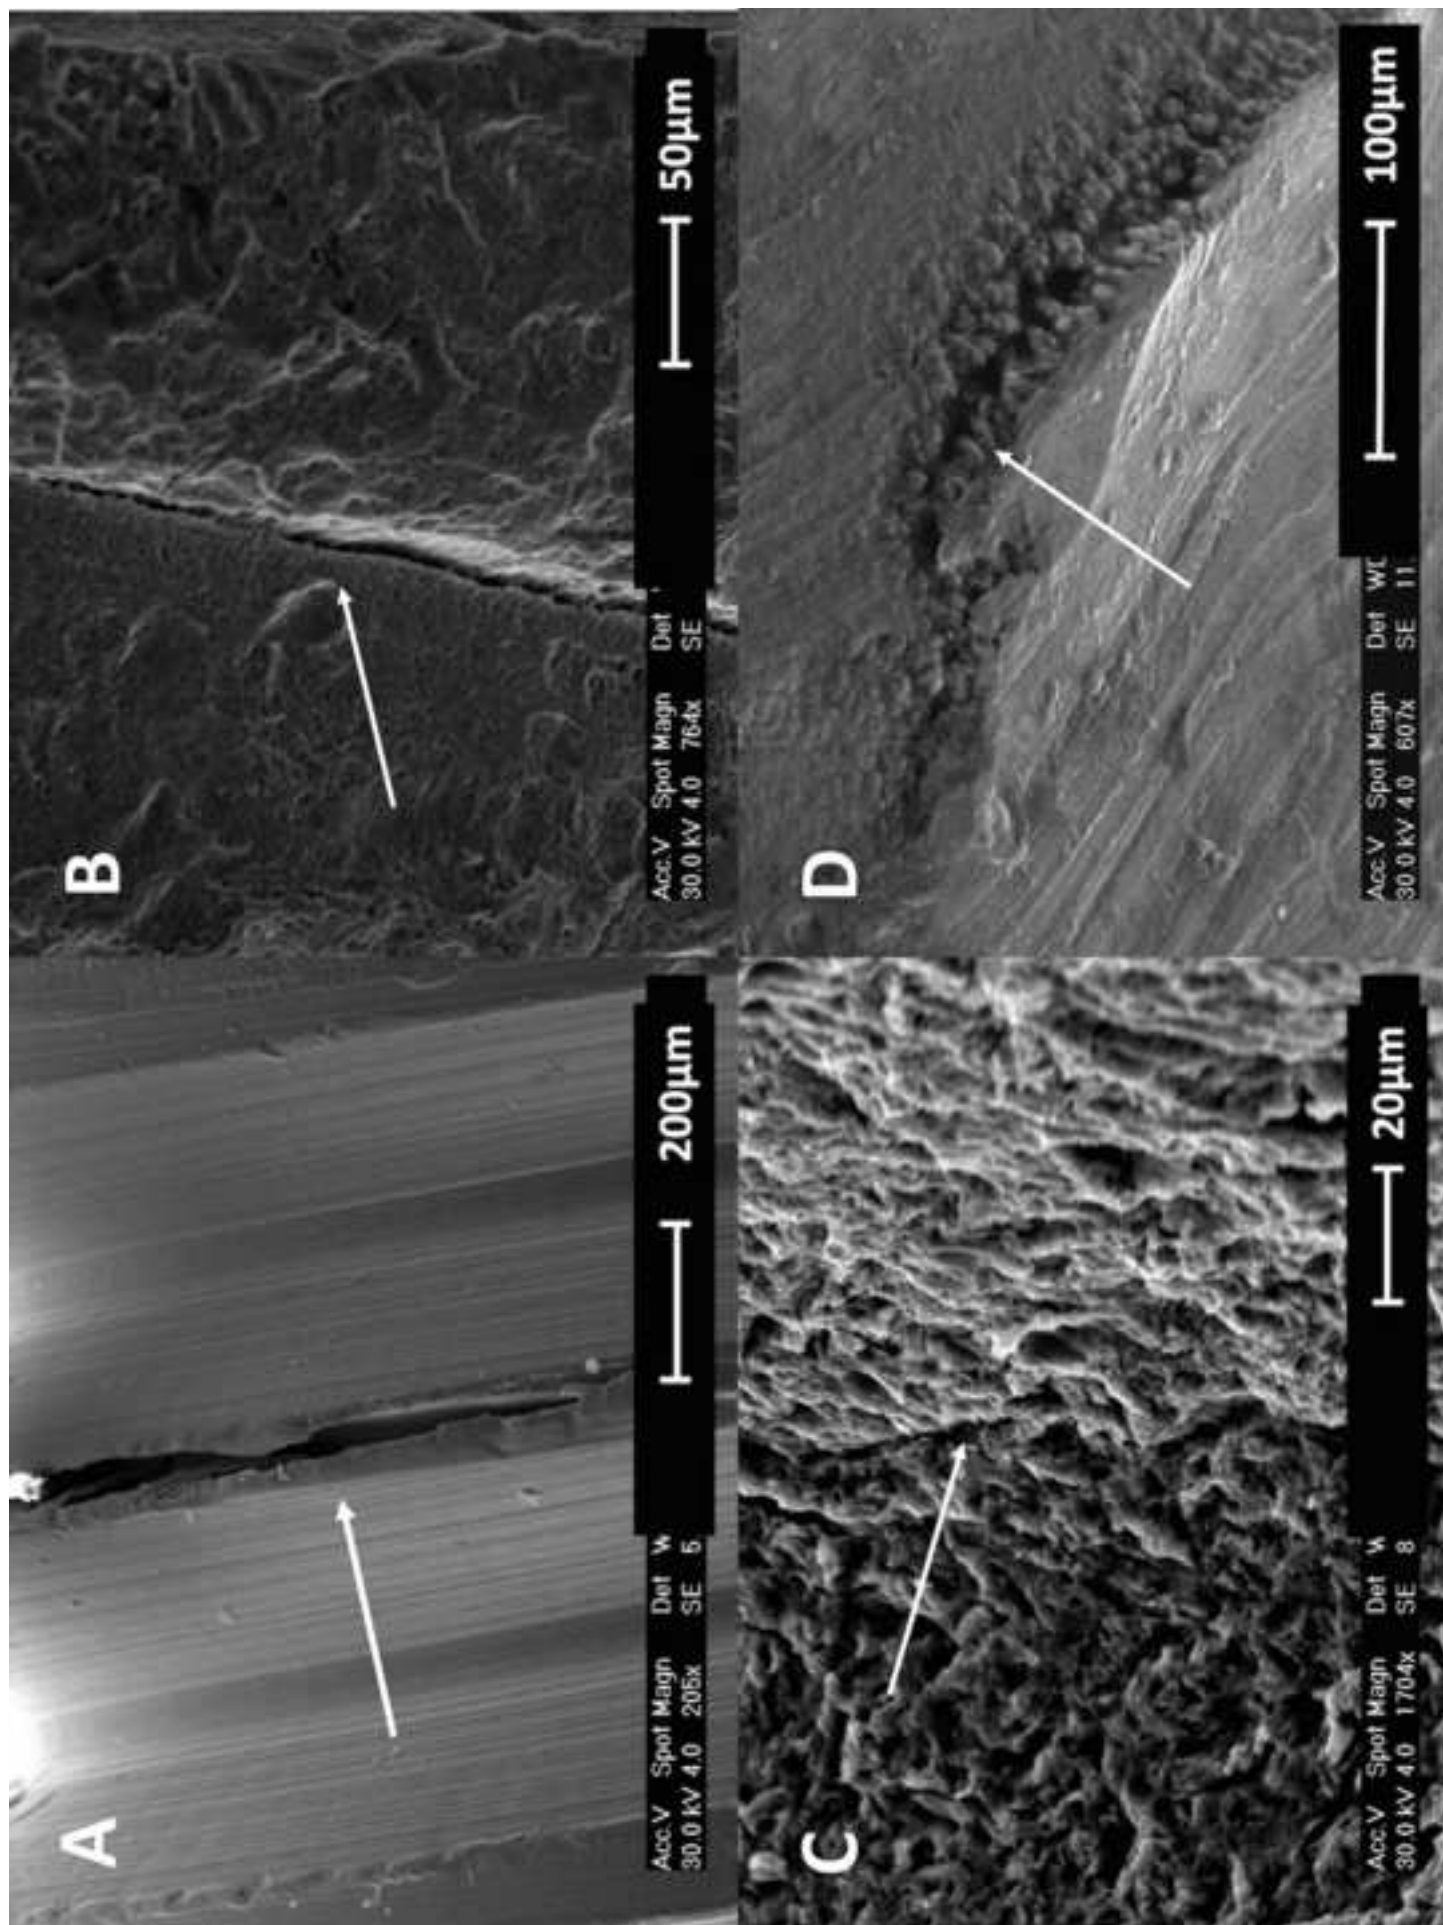
Figure 2

Mechanical defects were identified on the scanned surfaces of the implants. The defects were (arbitrarily) divided according to their length and appearance. Defects that had a length exceeding 0.5mm were defined as “full cracks” (see Fig. 2).

**Figure 2:** "Full cracks" (white arrows): SEM micrographs of surface defects defined as "full cracks". A. As-machined, B. Grit-blasted and etched, C. TPS, and D. Anodizing. The white arrows mark "full cracks".

Altogether, 62% of the implants contained defects, of which 28% were full cracks, and 34% were crack-like defects. Surface defects can be generated during the surface preparation treatment, as shown for grit-blasted specimens.<sup>21</sup> However, the observed defects on the

examined commercial implants before implantation and loading, were quite abundant, and consisted essentially of craters. This is in contrast with the number and typical morphology of the crack-like defects observed in the present work, which were deeper and wider, as characteristic of full cracks.

In addition, none of the examined implants exhibited signs of gross plastic flow that would unavoidably precede crack/ flaw formation in the investigated ductile materials, had they been subjected to overload during implant extraction or insertion. Likewise, no signs of wear or tool markings, all indicative of a surgical procedure, were observed in the vicinity of the defects. It can therefore, be reasonably assumed that the present crack-like defects and full cracks were in fact generated during the implant's use. Finally, note that the defect classification used here is arbitrary, in the sense that the defects' length is continuously distributed, so that irrespective of their denomination, those are all defects.

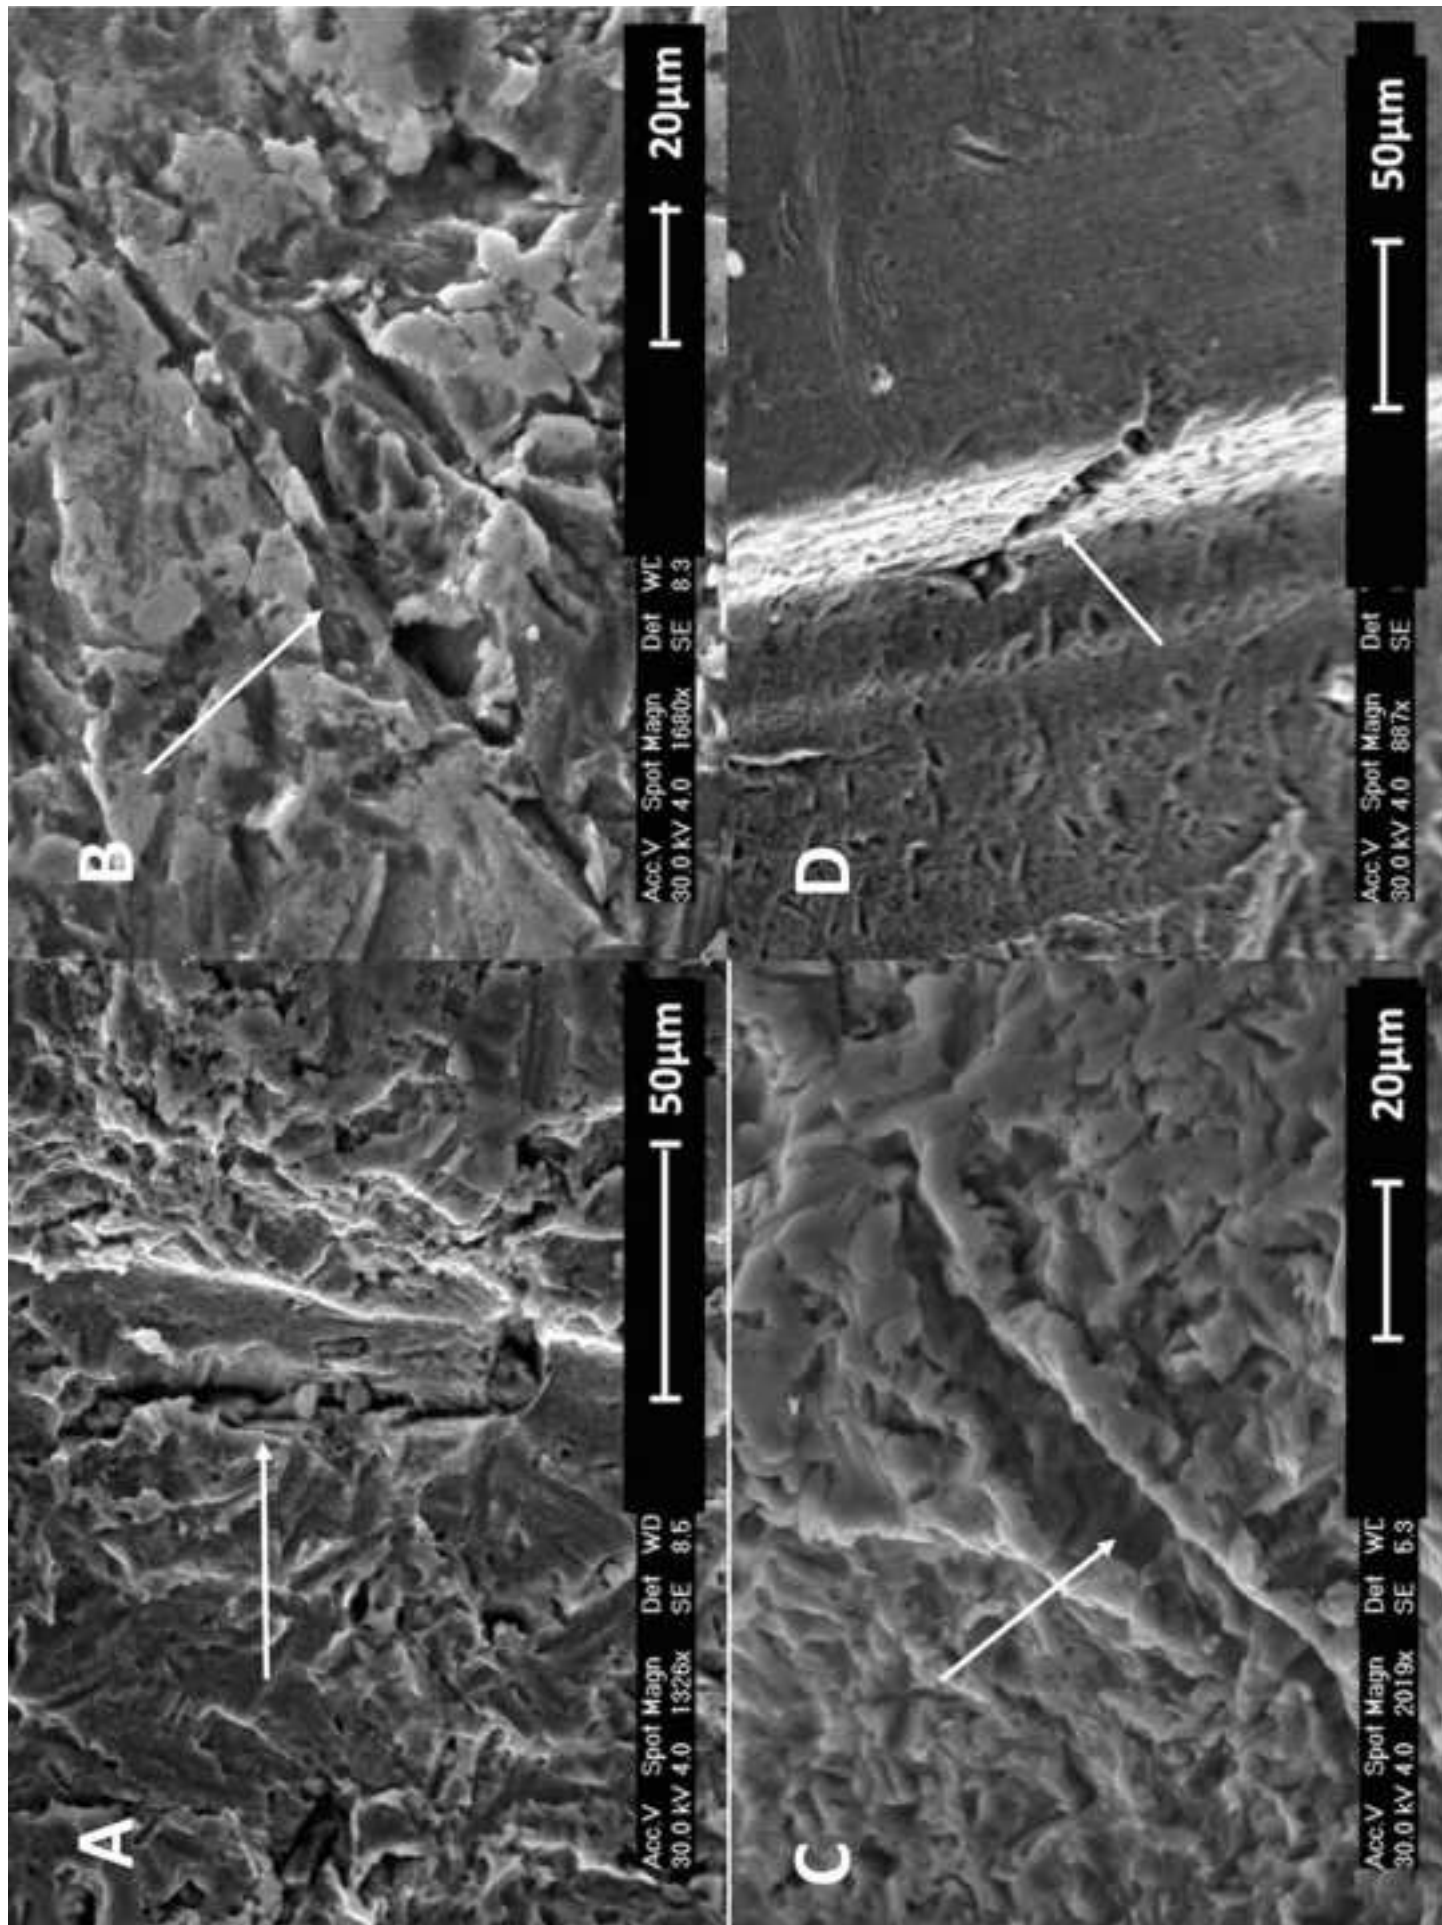
Figure 3

Defects with a length between 25 $\mu$ m-100 $\mu$ m were defined as “crack-like defects” (Fig. 3).

**Figure 3:** "Crack-like defects (white arrows)": SEM micrographs of surface defects defined as "crack-like" A.and B. Grit-blasted and etched. C. coated TPS. D. Grit-blasted only.

The clear novelty of this analysis is that a very large percentage of the retrieved implants contains various grades of defects, ranging from crack-like to full cracks. Depending on time, crack-like defects, which can be regarded as a stress concentration, have a high probability of developing into full cracks. Once present, the crack-like defect may grow into a single structural crack, due to the repeated character of mastication loads (fatigue), by coalescing with other crack-like defects until a full main crack is formed. In that respect, the crack-like defect is the embryo of the future crack that will grow with time and lead to implant fracture.

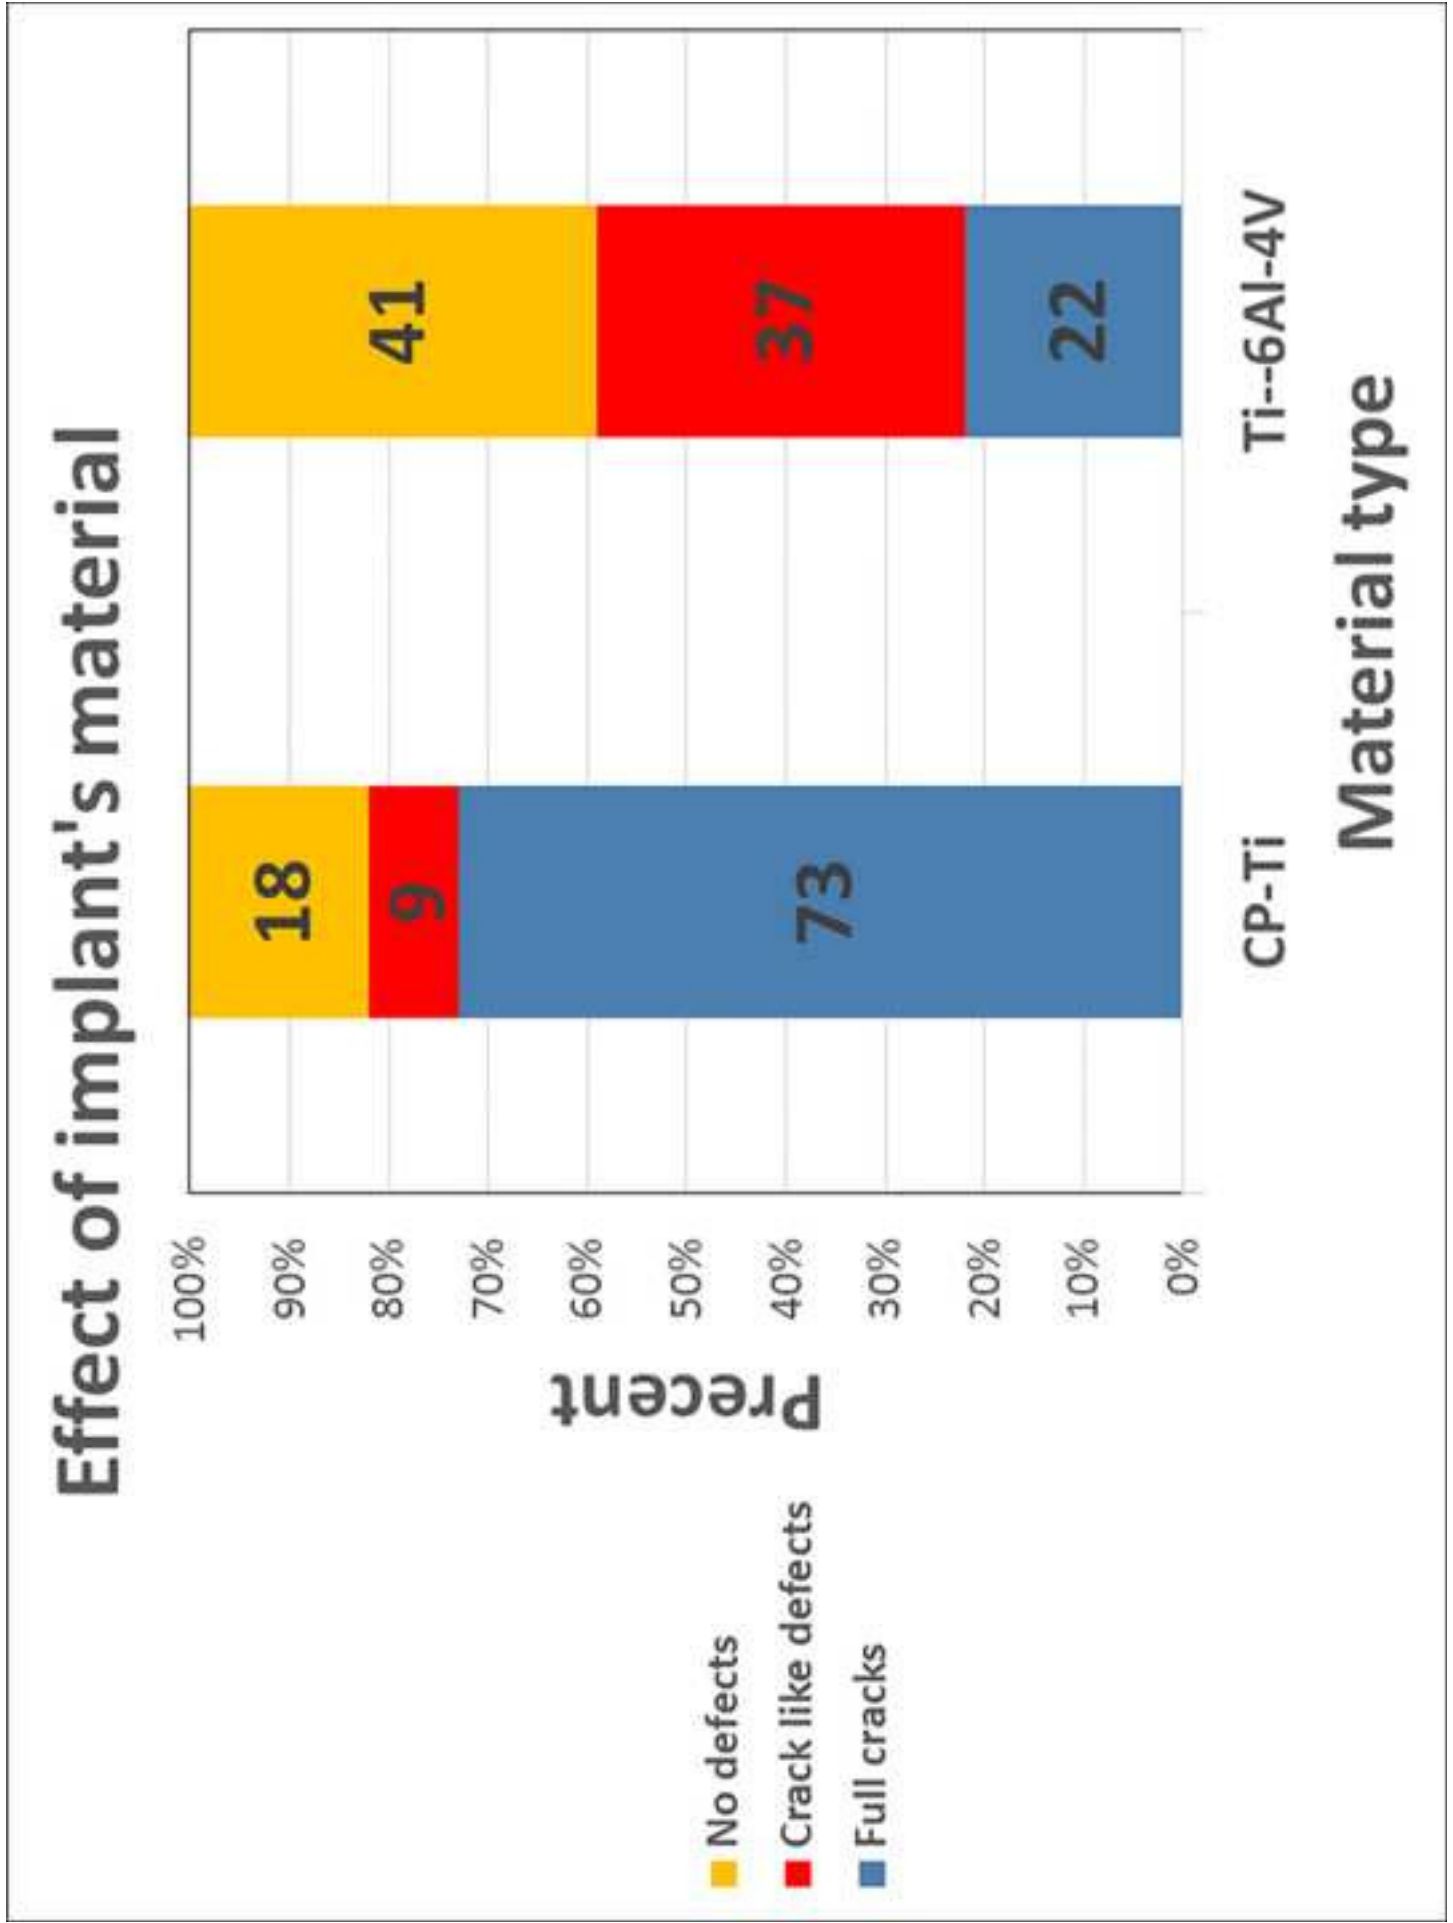
Figure 4

Fig. 4 presents the distribution per nature of the defects for the 2 implants' materials (Table 2).

The statistical analysis reveals that there is a definite correlation between the implant's material and the frequency and nature of observed defects ( $P= 0.038$ ). This observation might indicate that CP-Ti is more prone to developing mechanical damage. This may be based on the fact that, for a similar geometry and mastication loads, the relative (normalized by yield strength) stress is lower for the stronger Ti alloy as compared to the CP-Ti. Lower cyclic stresses are known to confer a longer overall structural fatigue life.

**Figure 4:** Effect of the implants' material on the various identified defects.

Implants' material is usually chosen for its combination of biocompatibility and mechanical strength. This study indicates that for the two identified materials, namely CP-Ti and Ti6Al4V alloy, given the mechanical design constraints of the implants, both have a marked tendency to cracking. Even so, the present results and statistical analysis seem to indicate that the Ti6Al4V alloy, with a higher tensile strength (therefore experiencing lower cyclic relative stresses), possesses a higher resistance to cracking than CP-Ti. A stronger statement would necessitate a controlled experimental study.

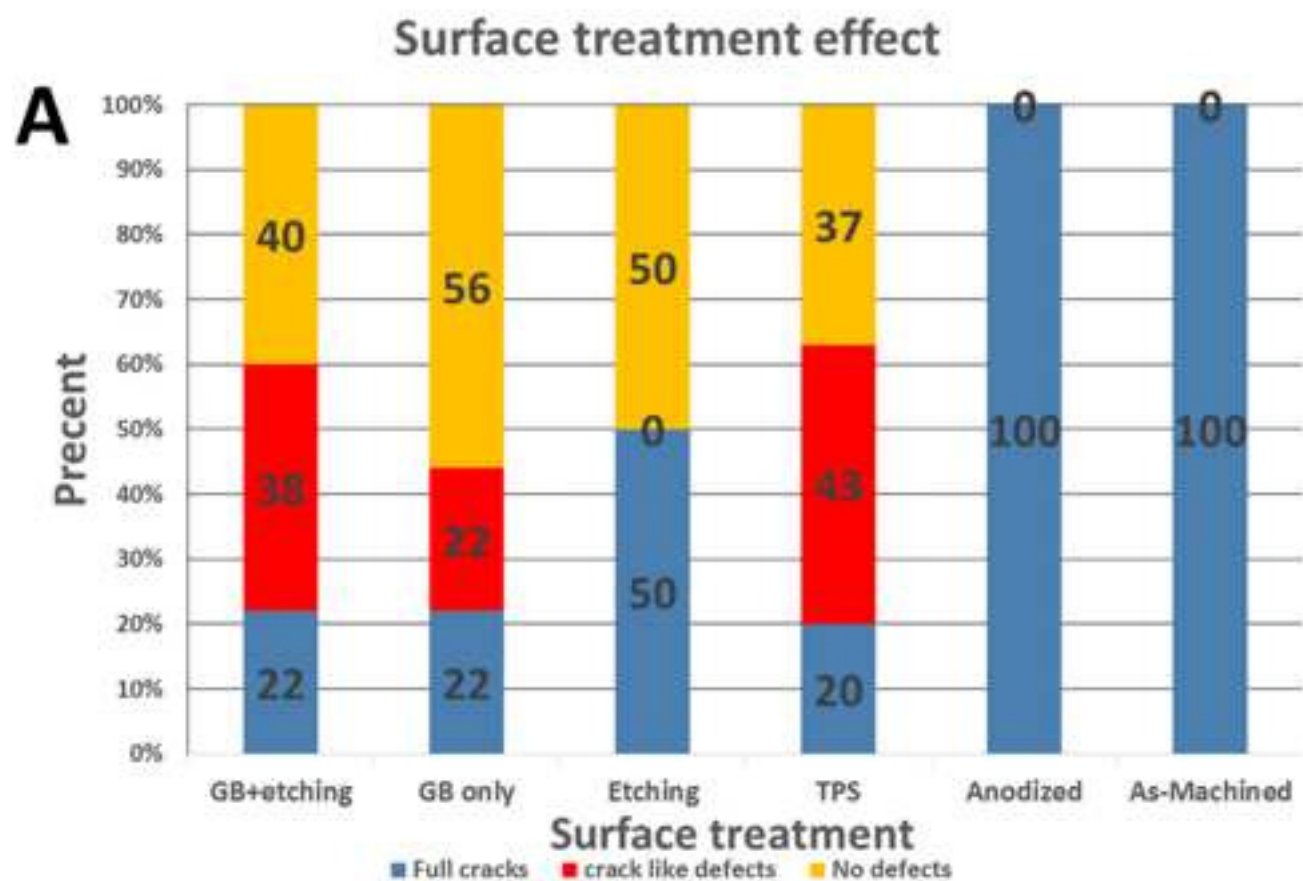
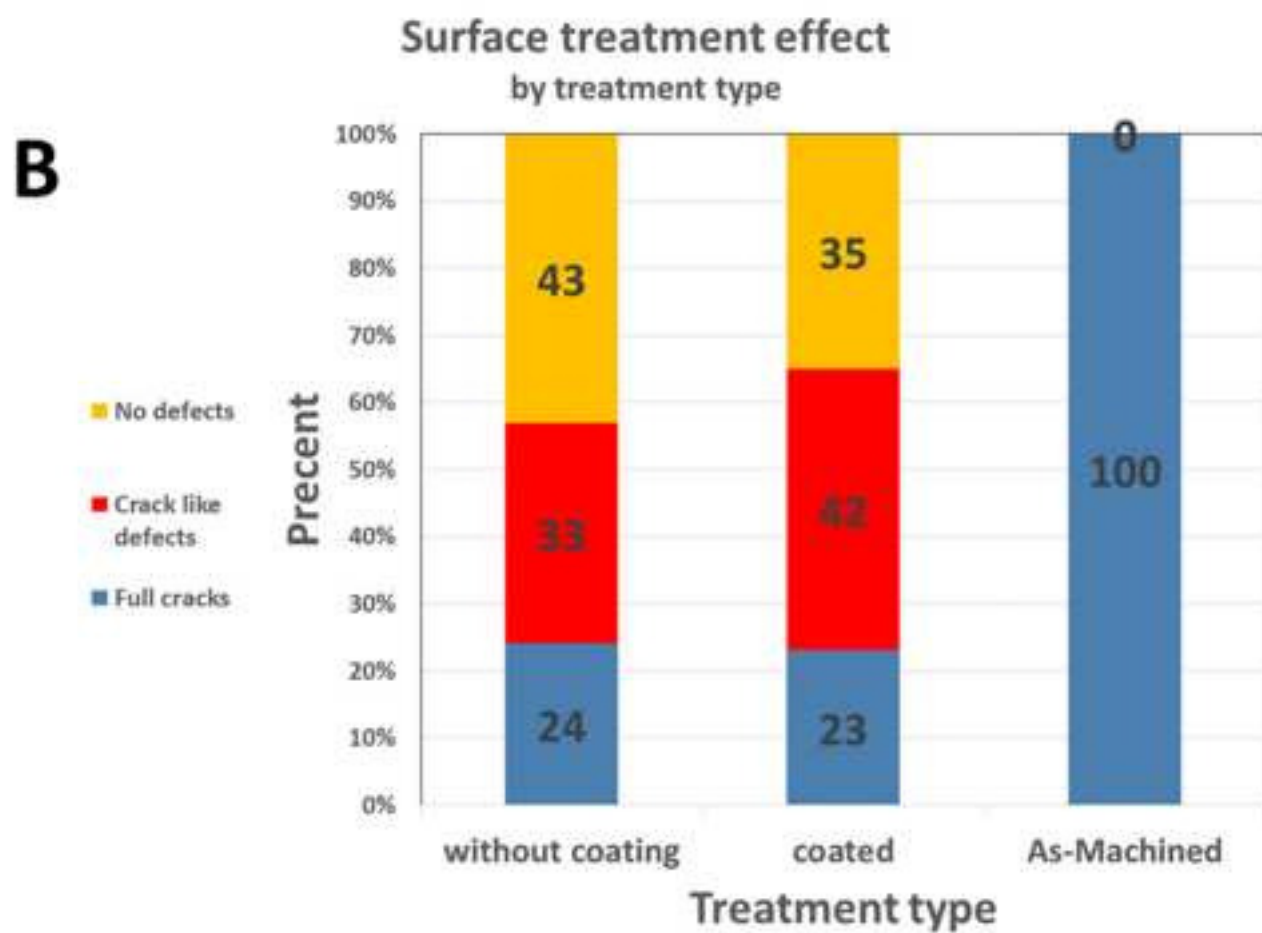
Fig. 5A shows the distribution of the defects per surface treatment, while Fig. 5B considers the three above-defined groups, namely as-machined, coated and without coating.

The following statistical analysis considers the relationship between the type of surface treatment and the observed defects (as shown in Fig. 5B). Here, a definite correlation exists ( $P=0.006$ ). However, when “coated” and “without coating” implants are compared in terms of defects, it is found that there is no significant difference between those groups.

**Figure 5:** Effect of the implants' surface treatments on the various identified defects A. Distribution of the defects per surface treatment. B. Distribution of the defects per surface treatment type (e.g. coated, uncoated and as-machined).

Those results are probably related to the fact that as-machined implants are no longer manufactured today, and the collected as-machined implants were most likely retrieved after a longer service time, therefore with a higher probability for containing cracks. This supports defect causation with function rather than during handling or placement.

Surface treatments are selected to optimize osseointegration. A great variety of surface treatments exist today, in order to achieve a desired degree of surface roughness.<sup>22</sup> In this study, all the various surface treatments were found to contain at least crack-like defects. If one does not consider the obsolete type of as-machined implants, no statistically meaningful difference between the various surface treatments could be identified. It can nevertheless be concluded here that the desired degree of surface roughness that will improve osseointegration, be it achieved either through coating or grit-blasting, might also promote the adverse effect of cracking, a fact that is well known as stress concentration effect in solid mechanics<sup>23</sup>.

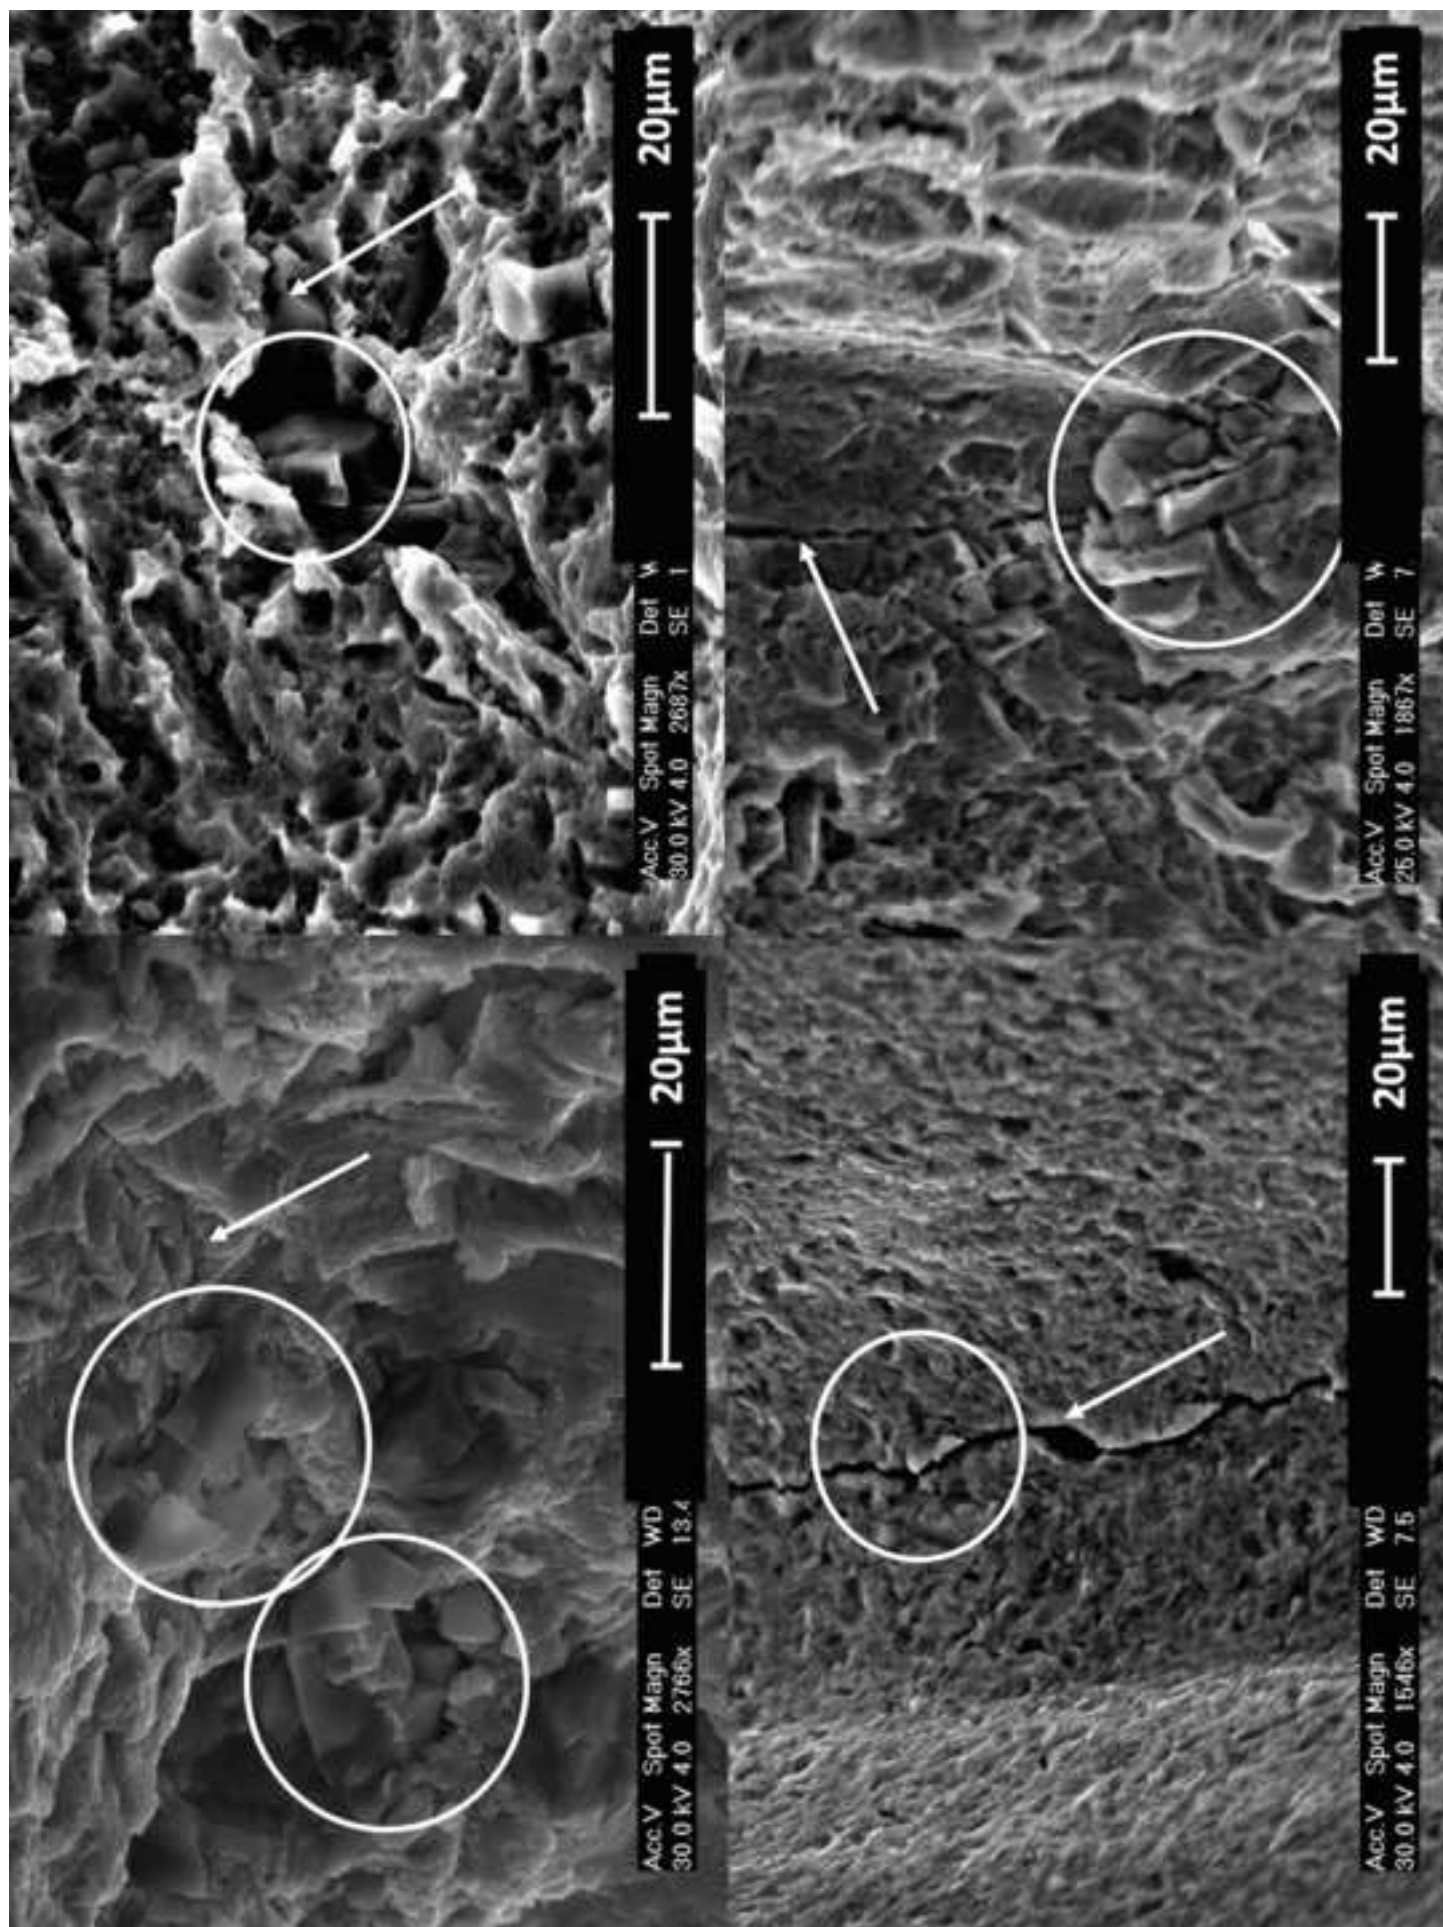
Figure 6

Examination of the grit-blasted (with or without etching) implants further revealed the presence of embedded foreign particles in both crack-like defects and full cracks alike, as exemplified in Fig. 6.

Among implants that underwent grit-blasting surface treatment (e.g. GB+etching and GB only), 85% of full cracks (11/13) and 76% of crack-like defects (16/21) showed involvement of embedded foreign particles. No statistical correlation was found between the involvement of embedded foreign particles and the type of defects (full cracks or crack-like defects)

( $P >> 0.05$ ). This points to the same probability of finding embedded foreign particles in full cracks as in crack-like defects. In other words, this result shows that the particles' involvement is the same from the "early" crack-like defects stage to the later stage of full grown cracks.

**Figure 6:** Embedded foreign particles on full cracks and crack-like defects, as identified on grit-blasted (with or without etching) implants. The white arrows mark the defects (full cracks or crack-like defects) and the white circles indicate embedded foreign particles.

Moreover, we observed that, in implants subjected to a grit-blasting treatment (with or without etching), numerous embedded foreign particles were associated with crack-like defects or full cracks. In addition to the very high involvement of the particles in the incidence of defects (>75%), no further statistical correlation was found between their presence in crack like defects and full cracks. Crack-like defects can be regarded as crack embryos (preferential site) for fatigue crack nucleation. Our results show that the proportion between the defect type and the particles presence is constant, without significant statistical difference. This suggests that the same proportion of crack-like defects, caused by impact of foreign particles, is likely to evolve into later full cracks with minimal involvement of additional fatigue cracks

originated for other than particle-related reasons. This observation further strengthens the relation between cracks and foreign particles, from the nucleation to growth stages. Those findings are fully consistent with previous work<sup>21, 24</sup> which singled out the potentially deleterious effect of embedded foreign particles on the development of fatigue cracks.

In this context, note that Shemtov-Yona et al.<sup>21</sup> presented a fractographic analysis of 15 retrieved fractured CP-Ti and Ti-6Al-4V dental implants, and identified fatigue as the main fracture mechanism. When the surface of the implants was examined, numerous secondary cracks were identified in the vicinity of the main crack. These secondary cracks did not lead to the final fracture, but they did also reveal the relationship of the secondary cracks to the fracture surface topography (roughness), and to embedded ceramic particles, which resulted from the grit-blasting surface treatment.

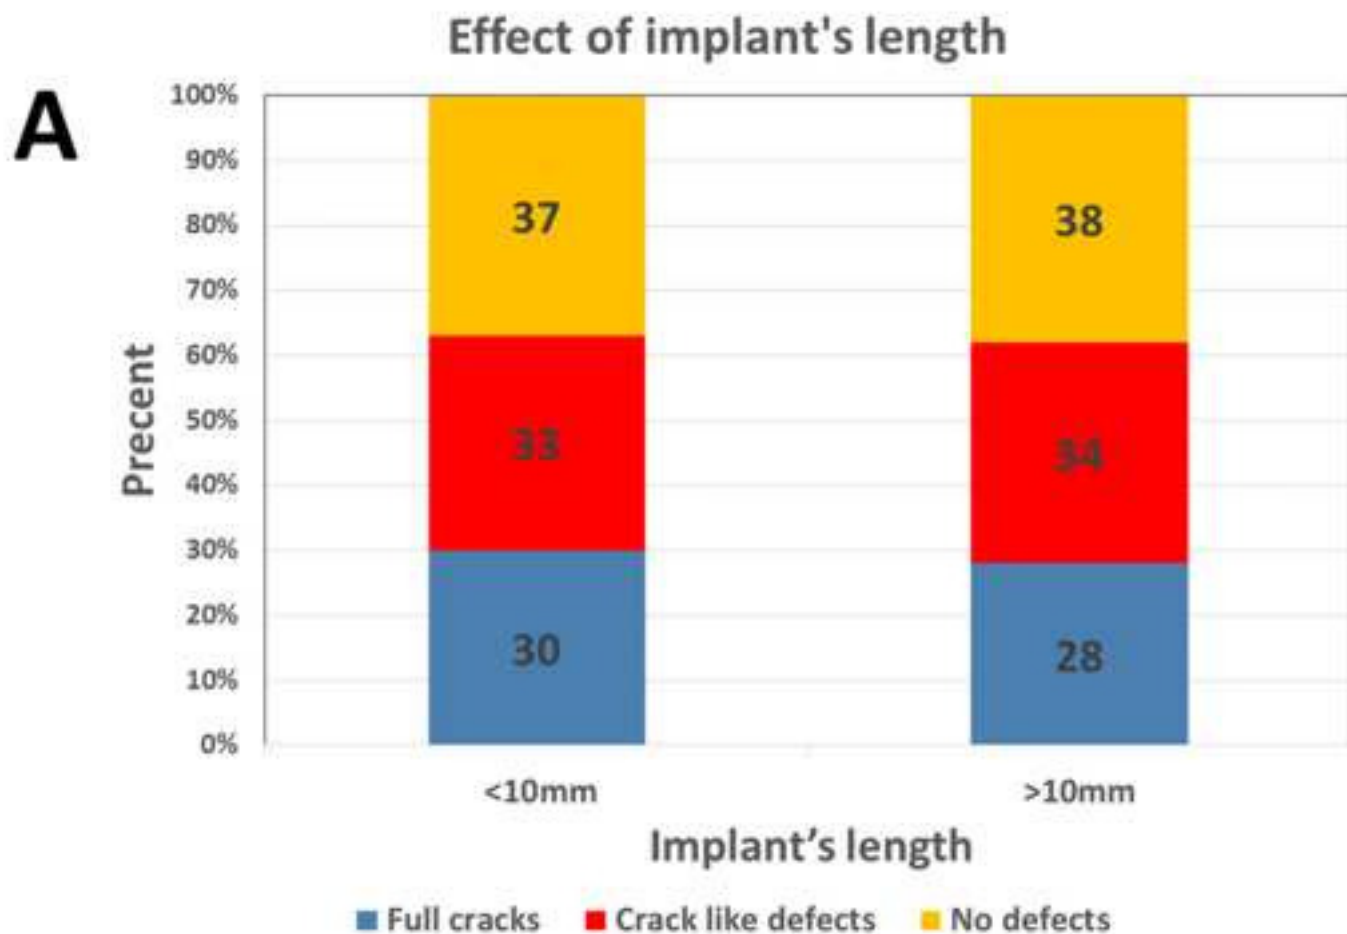
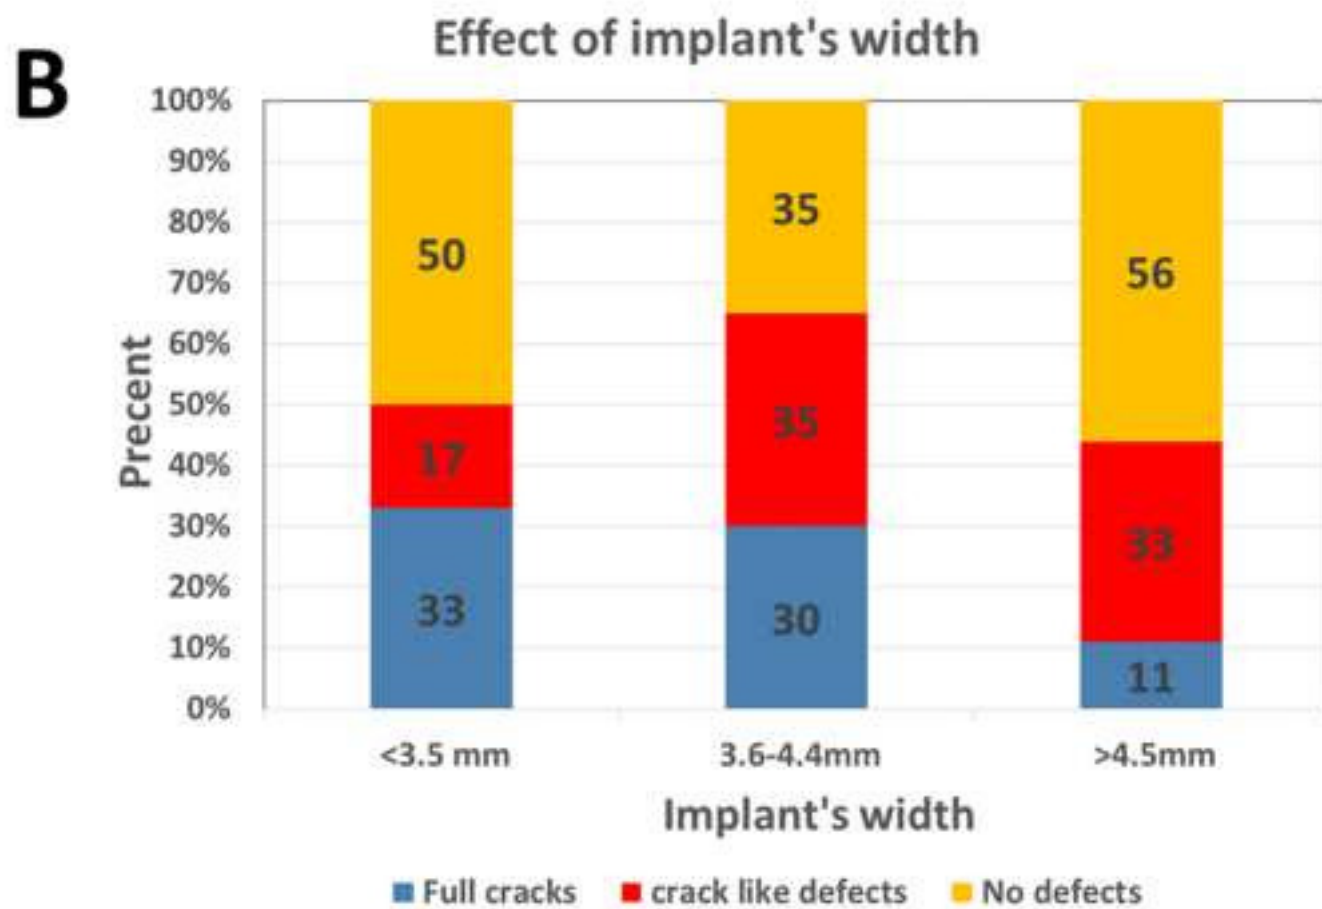
Fig. 7 shows the distribution and nature of observed defects for implants of variable length (7A) and diameter (7B).

For both the length and width parameters, the statistical analysis indicates an apparent lack of correlation ( $p >> 0.05$ ) in terms of defect types.

**Figure 7:** Effect of the implants' design on the various identified defects A. Effect of length B. Effect of diameter.

Examining the effect of implant's design (diameter and length) on the identified defects, our results show that both the length and the width of the implants have apparently no substantial influence on their mechanical integrity. The effect of implant diameter was previously studied "in-vitro",<sup>17</sup> where narrow implants exhibited a lower fatigue strength and earlier failure. In that context, one should note, that a higher incidence of implant fracture has been reported in narrow implants.<sup>25</sup> The current results do not confirm those observations when the two implant materials are considered together, but it must be kept in mind that each implant has its own mechanical history, as opposed to carefully controlled fatigue testing, as e.g in<sup>17</sup>.
