**Failure by simultaneous grain growth, strain localization, and interface debonding  
in metal films on polymer substrates**

Nanshu Lu, Xi Wang, Zhigang Suo, Joost Vlassak

*School of Engineering and Applied Sciences, Harvard University, Cambridge, MA 02138, USA*

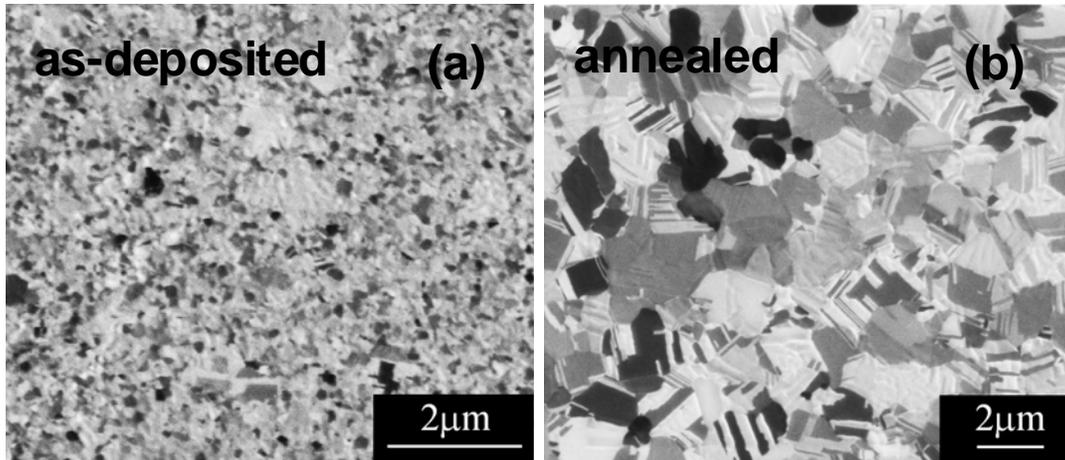
Figure 1. FIB images of (a) as-deposited film and, (b) film annealed at 200°C for 30 minutes.

The anneal has caused significant grain growth. While grains have a relatively uniform distribution in the annealed film, isolated large grains can be identified in the as-deposited film.

To understand the mechanism of rupture in as-deposited films we first review the more straightforward case, i.e., fracture of annealed copper films under uniaxial tension. From a comparison of Figs. 1(a) and (b), it is evident that annealed specimens have a more uniform microstructure than as-deposited films, with a relatively large grain size of 1.5  $\mu\text{m}$ . Moreover, the microstructure of the annealed films remains stable during the deformation, i.e., no grain growth takes place during plastic deformation. Consequently the annealed films deform relatively homogeneously until simultaneous delamination and strain localization lead to failure of the films [23].

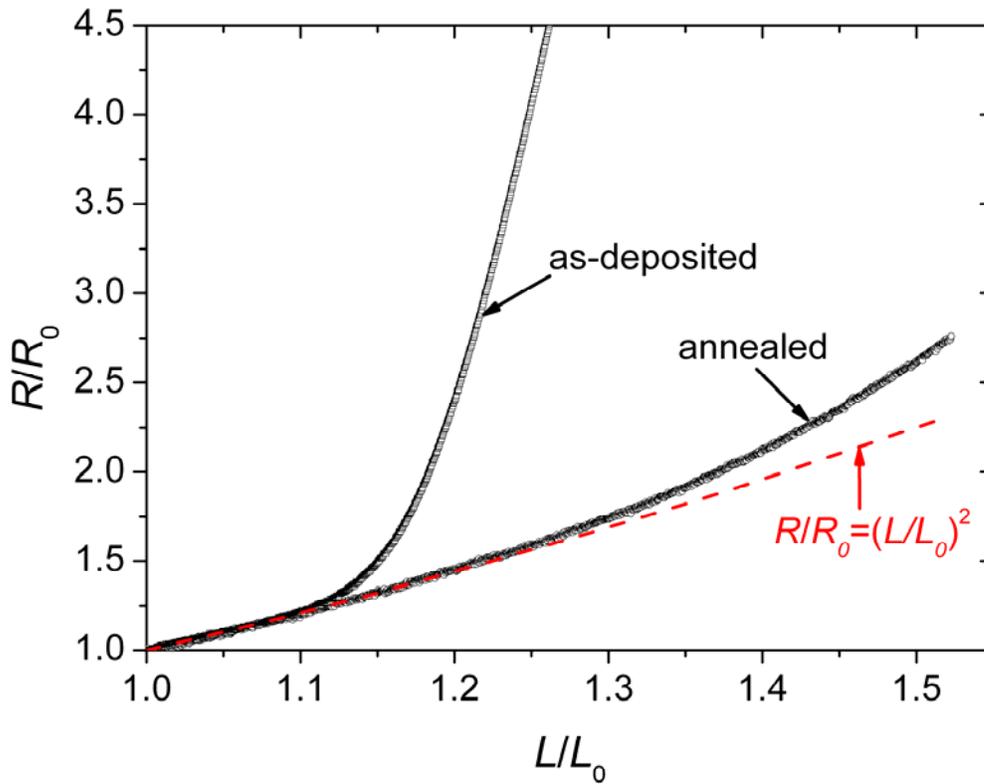
Figure 2. When a metal film on a polymer substrate was pulled, the electrical resistance  $R$  of the film increased with the length  $L$  of the film. The resistance and the length are normalized by their initial values,  $R_0$  and  $L_0$ . The theoretical prediction,  $R/R_0 = (L/L_0)^2$ , assumes that the film deforms homogeneously and that the resistivity is unaffected by the deformation. The measured resistance of the as-deposited film starts to blow up at an elongation about 12%, while that of the annealed film starts to deviate from the theoretical prediction at an elongation about 25%.

Equation (1) implicitly assumes that the electrical resistivity of the films does not change during plastic deformation of the film. Figure 2 plots the normalized resistance  $R/R_0$  as a function of the normalized length  $L/L_0$  for both as-deposited and annealed specimens. The dashed line is the theoretical prediction according to Eq. (1). The resistance of as-deposited films deviates rapidly from the guideline at an elongation of approximately 12%. This sudden departure in the film resistance is caused by the formation and propagation of cracks in the Cu films, as confirmed by post-mortem SEM observations (Fig. 3). Isolated microcracks are observed at low magnification after the specimen is strained by 15% (Fig. 3a). Cracks become interconnected and severe debonding can be observed at an elongation of 40%, as is evident in Fig. 3(b). The micrographs in Figs. 3(c) and (d) provide a closer look at the crack morphology for elongations of 15% and

The behaviour of annealed specimens is distinctly different. Fig. 2 shows that the resistance of annealed films starts to slowly deviate from the guideline at an elongation of 25%, indicating very little cracking. This observation was confirmed by post-mortem SEM microscopy. Typical micrographs are shown in Fig. 4. Films deformed to 30% (Fig. 4a) and to 50% strain (Fig. 4b) show clear evidence of fracture, although the crack density is much lower than in as-deposited films. Films deformed less than 25%, on the other hand, do not show any evidence of fracture (not shown). The deviation from the theoretical resistance curve is only induced by the formation of cracks in the film and not by an increase in dislocation density as a result of plastic deformation. We know this because very similar Cu films on Kapton substrates, but with a thin Ti or Cr adhesion layer to improve bonding to the substrate, can be plastically deformed to 50% without any appreciable deviation from the theoretical resistance curve [23]. At higher magnification, both intra- and inter-granular cracks can be observed in the annealed films (Fig. 4c and d). Slip traces are also clearly visible within each grain, indicative of the extensive plastic deformation that occurred in these films. Cross-sectional images of the cracked regions (Fig. 3 in Ref. [23]) reveal that annealed Cu films eventually rupture through co-evolution of necking and debonding from the substrates, in good agreement with finite element simulations [10, 11].

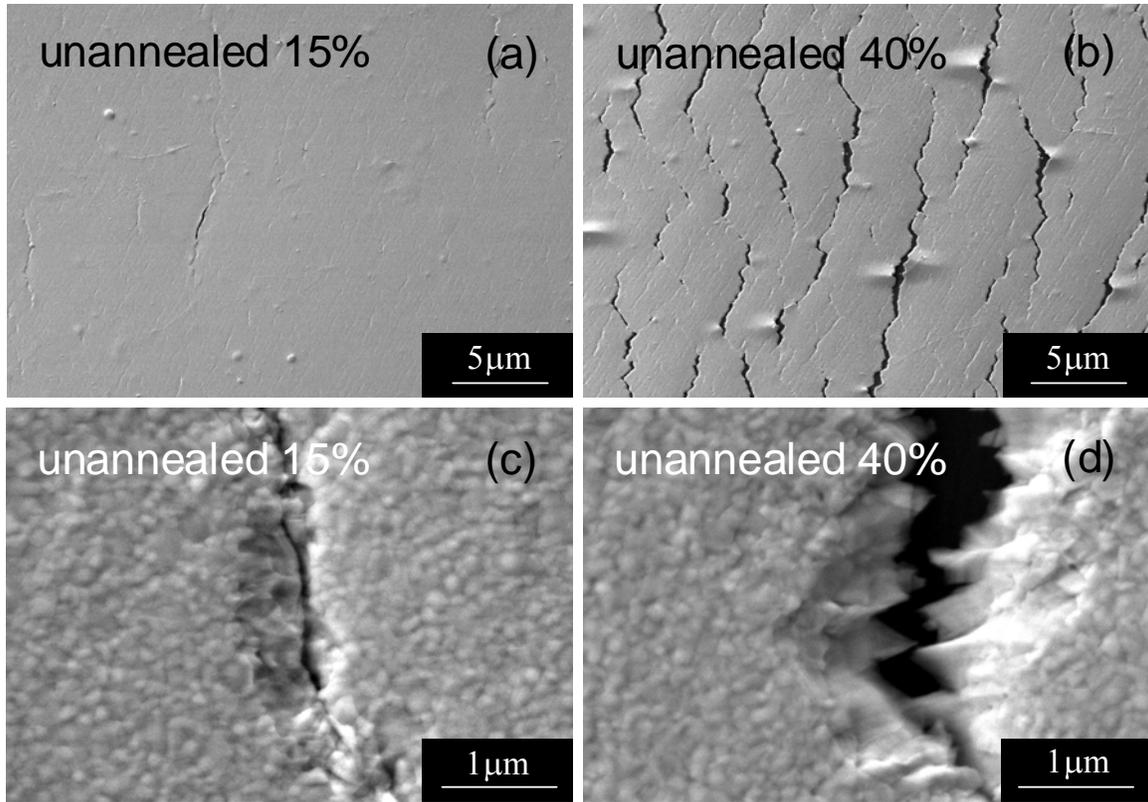
Figure 3. SEM images of as-deposited films after deformation of (a) 15% and (b) 40%. Multiple neckings and isolated cracks can be found at an elongation of 15% whereas denser and interconnected cracks appear after 40% deformation. (c) and (d) show cracks of higher magnification at 15% and 40% strain. Large local elongation along crack path and saw-tooth profile are indications of significant plastic flow.

40%, respectively. Significant plastic flow is evident from the saw-tooth profile of the crack faces.

mechanisms, strain localization and grain growth, facilitate each other and lead to ductile film rupture at relatively small overall strains as shown in Figs. 3(c) and (d).

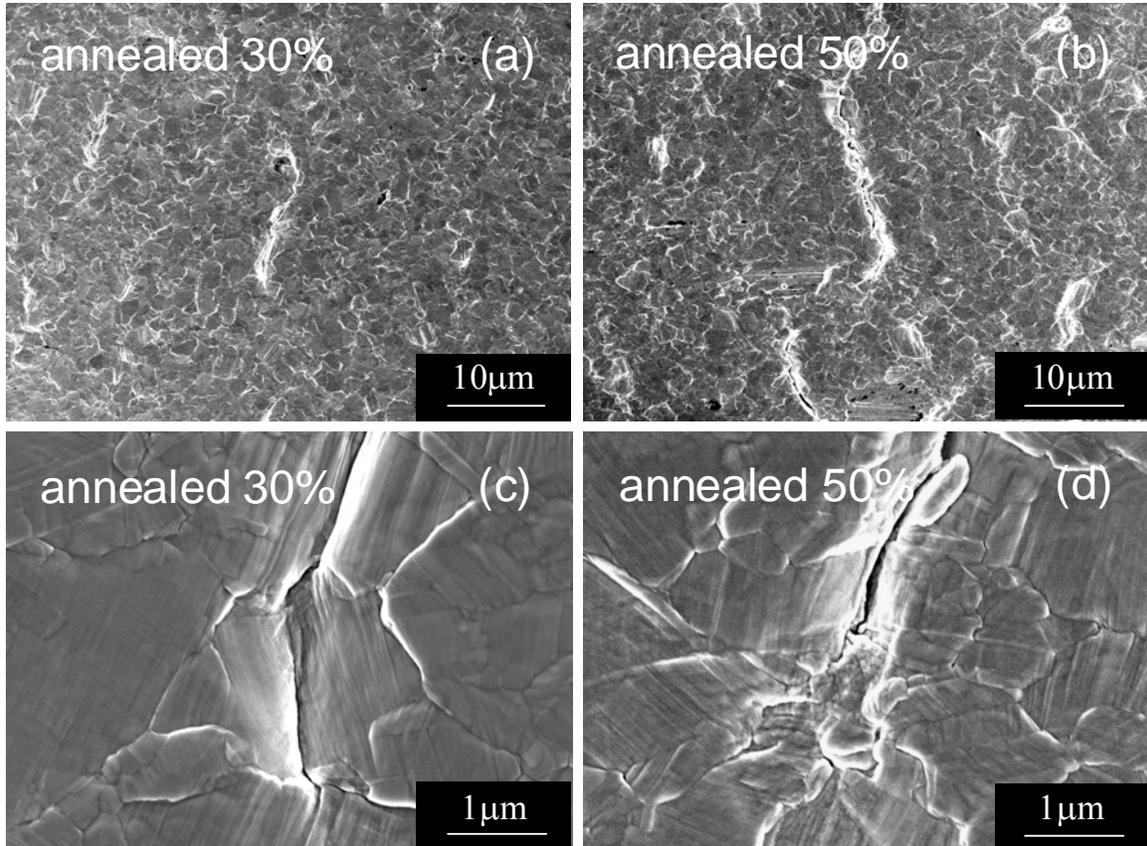
Figure 4 SEM images of surface morphology of annealed films at strains of (a) 30% and (b) 50% at a low magnification. Few cracks can be observed at strains of 30% strain and slightly more can be found after strain of 50%. (c) and (d) show crack details at a higher magnification. Slip traces of dislocations are identified as parallel deformation lines within each grain. The fracture is both transgranular and intergranular.

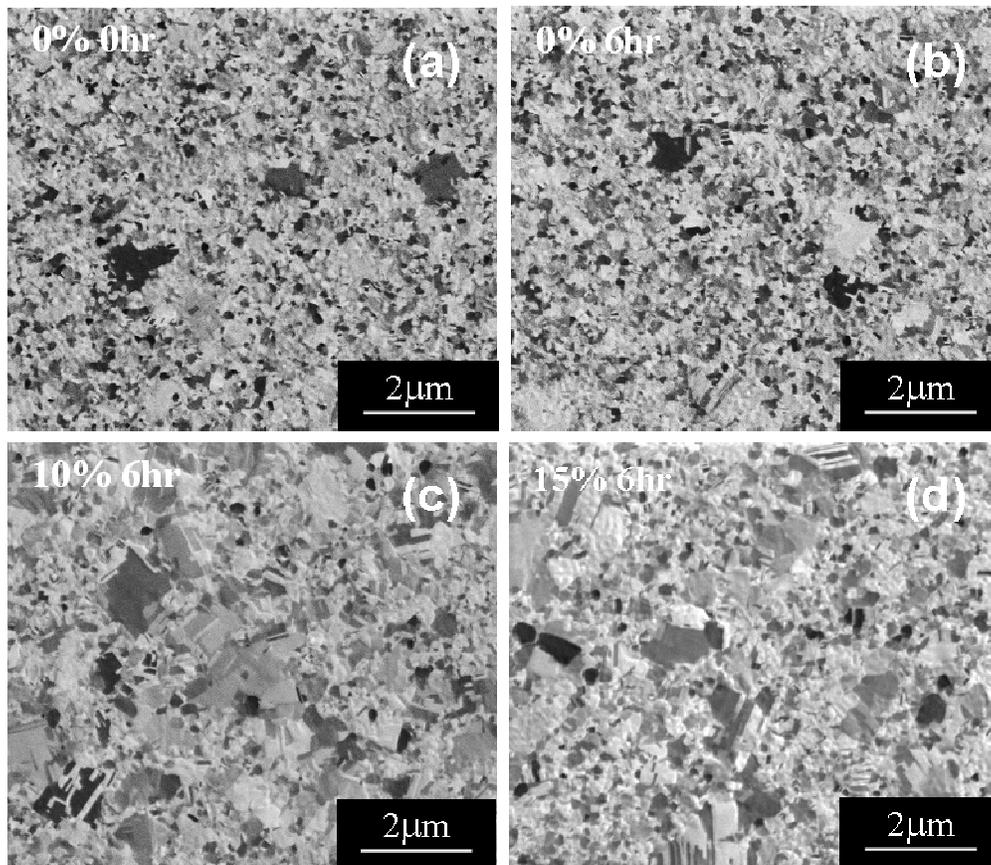
Figure 5. FIB images of films held at room temperature afterwards. (a) right after deposition. (b) 6 hours after deposition, subject to no load. (c) 6 hours after deposition, pulled by a strain of 10%. (d) 6 hours after deposition, pulled by a strain of 20%. A comparison of (a) and (b) indicates that the size of grains remained unchanged for a film subject no load. A comparison of (b), (c) and (d) indicates that the size of grains markedly increased when the film is pulled by 10% and 15%.

While the microstructure of the annealed copper films is stable under mechanical loads, the microstructure of the as-deposited films is not. Evidence of grain growth in the as-deposited films during deformation is presented in Fig. 5, which shows the evolution of the grain structure during deformation. Figure 5(a) shows a plan view of an undeformed, as-deposited Cu film immediately after deposition. Although most grains are less than 90 nm in size, there are a few large grains of micron size embedded in the matrix of nano-grains. Few if any twin boundaries can be identified in the film. Figure 5(b) shows a micrograph of the same undeformed specimen taken six hours after deposition. There is no significant difference in grain size distribution, indicating that no grain growth takes place in undeformed specimens at room temperature on the timescale of the experiment. Figures 5(c) and (d) are post-mortem FIB micrographs of specimens stretched to 10% and 15% strains respectively, also taken six hours after deposition. The only difference between the specimen shown in Fig. 5(b) and those shown in Figs. 5(c) and (d) is that the latter two were plastically deformed. As is evident from the micrographs, there are significant microstructural differences between the specimens: while a few isolated large grains can be observed in undeformed specimen, the deformed films contain many such grains. Grain growth is clearly discontinuous in that a strong bimodal grain size distribution develops. Several mechanisms have been described to explain discontinuous grain growth in nano-crystalline metal films [27]. These include grain growth driven by a reduction in surface energy [29], elastic strain energy [30], or stored deformation energy [31]. A simple energy calculation shows, however, that the driving forces for these mechanisms are smaller than for continuous grain growth. Stress-driven grain growth has also been observed experimentally in nano-crystalline Al films.

In contrast, as-deposited specimens have a bimodal grain size distribution: they are mostly nano-crystalline with a few large grains. The nano-crystalline sections of the films have a very high yield strength as a result of the Hall-Petch effect [29]. The large grains, on the other hand, are much easier to plastically deform. Such a microstructure naturally leads to nonuniform deformation. Furthermore, it is evident from Fig. 5 that the number of large grains increases

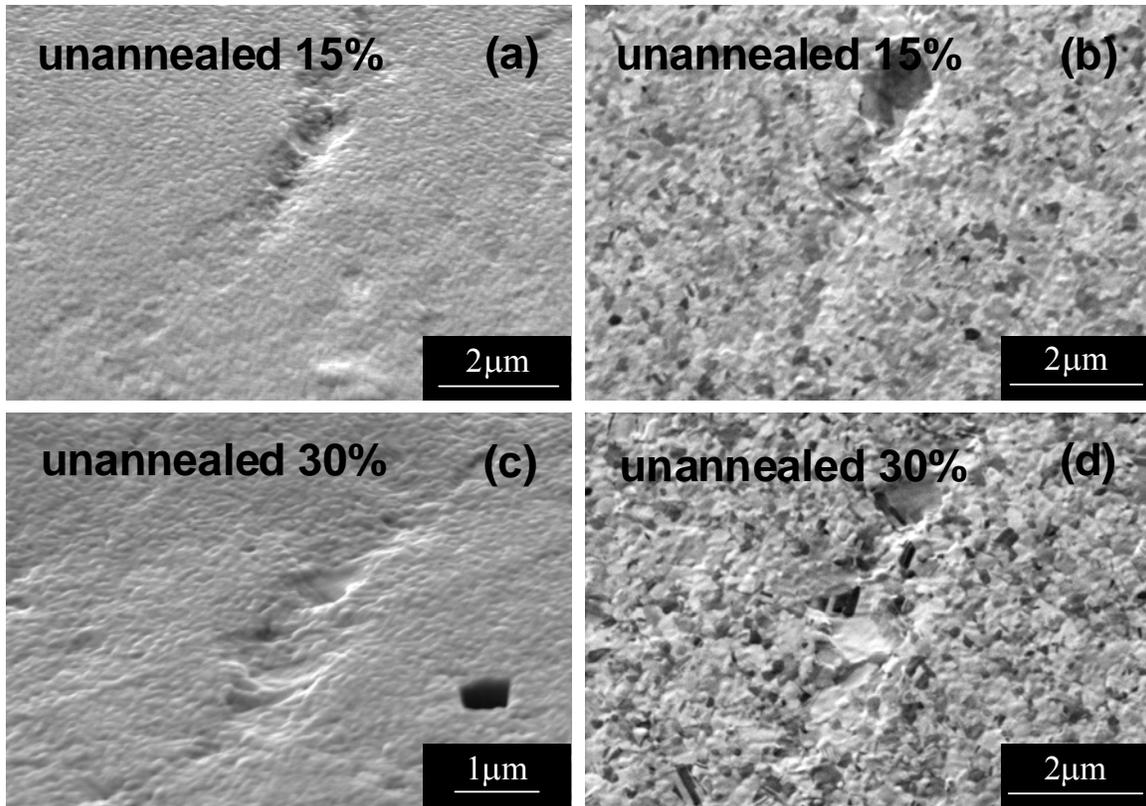
Figure 6. Images of strain localization in as-deposited films pulled by (a) & (b) 15%, (c) & (d) 30%. Severely necked region always contains at least one large grain.

during plastic deformation. This microstructure leads to deformation behavior that is significantly different from that of annealed films. Figure 6 shows two sets of micrographs taken by SEM and FIB of samples that were stretched by 15 and 30%. The SEM images show the surface topography, while the FIB images show the grain structure of the same areas of the films. Incipient necks can be observed in the SEM images (Figs. 6a and 6c). The corresponding FIB images in Figs. 6(b) and 6(d), and many others like them, show that these necks are associated with one or more large grains in the film. At 15% strain, the FIB image (Fig. 6b) shows that there are initially many nano-crystalline grains in the necked down area, even though the necks are usually associated with at least one large grain. At 30% strain, however, most of these small grains have disappeared and the areas of strain localization contain mostly large grains. Strain localization and large grains are closely correlated for sufficiently large deformations.

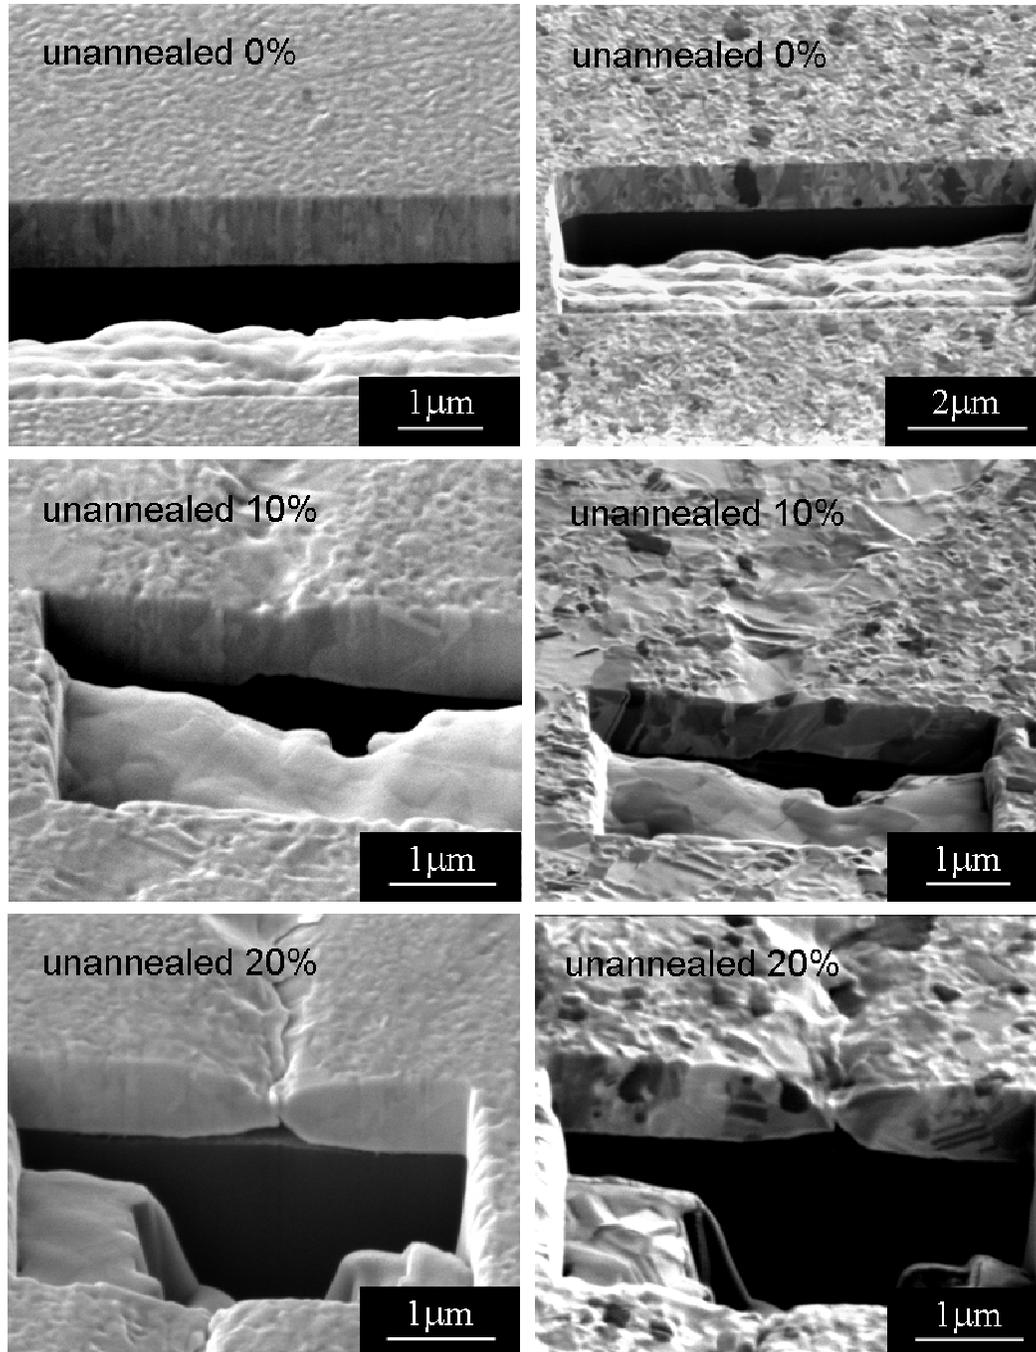
Figure 7. Cross sections created by using FIB. Images in the left column were taken by SEM, and images in the right column were taken by FIB. (a) Undeformed film. (b) Film pulled by 10%. (c) Film pulled by 20%. We observe that strain localization is accompanied by interface debonding.

To validate this interpretation, Fig. 7 shows cross-sectional images of unannealed specimens deformed to different elongations. Strain localization and debonding always co-evolve. Figure 7(a) shows a uniform Cu film well bonded to Kapton substrate prior to any deformation. The FIB image confirms that the grains do not have a columnar structure because multiple grains can be found through the film thickness. In Fig. 7(b) at 10% strain, local thinning has taken place along with debonding from the substrate, but few cracks can be found in the specimens. As illustrated in Fig. 7(c), microcracks can be observed in samples with an elongation of 20%. It is obvious that these cracks occur in regions of intense plastic deformation with local thinning and debonding. In conclusion, simultaneous strain localization and debonding are necessary ingredients for the rupture of a ductile film supported by a stretchable substrate. From this point of view there is no difference between annealed and as-deposited films.

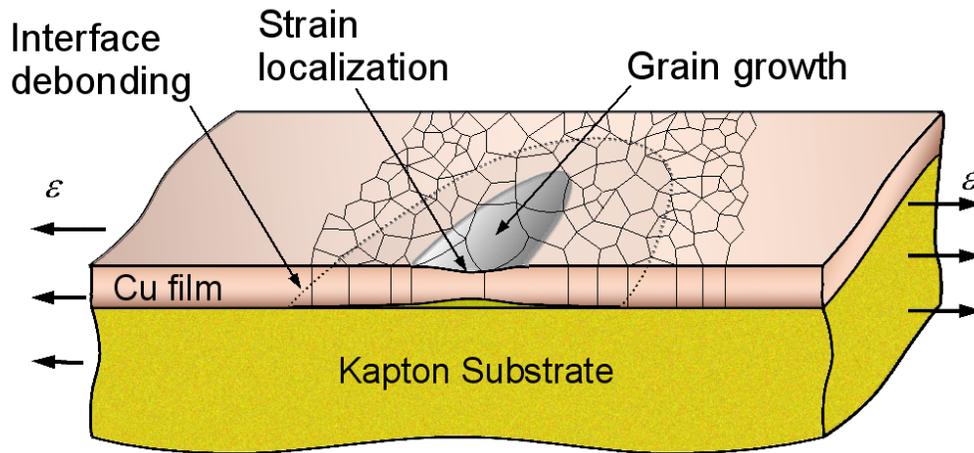
Figure 8. A schematic of concurrent processes: deformation-associated grain growth, strain localization promoted by large grains, and film/substrate interface debonding. The three processes co-evolve to form a neck.

The failure mode of as-deposited Cu films on polymer substrate is illustrated schematically in Fig. 8. Initially, the as-deposited film is mostly composed of nano-crystalline material with occasional micron-sized grains. Under tensile loading, large grains act as preferential sites for strain localization. Nano-crystalline grains in regions of strain localization start to grow with increasing strain, locally weakening the material and further promoting localization. As strain localization proceeds, tractions are exerted on the film/substrate interface. These tractions cause local delamination of the film, freeing it from the constraint of the underlying substrate. This process, in turn, promotes strain localization. Eventually the film necks down to a knife-edge. Micro-cracks form in the film and the resistance of the film increases suddenly. In short, the as-deposited Cu films fail through three concurrent mechanisms: strain localization at big grains, deformation-induced grain growth, and debonding from the substrate.
