The influence of environmental parameters on the dynamic behaviour of the San Frediano bell tower in Lucca

Riccardo Mario Azzara^a, Guido De Roeck^b, Maria Girardi^c, Cristina Padovani^c, Daniele Pellegrini^c, Edwin Reynders^b

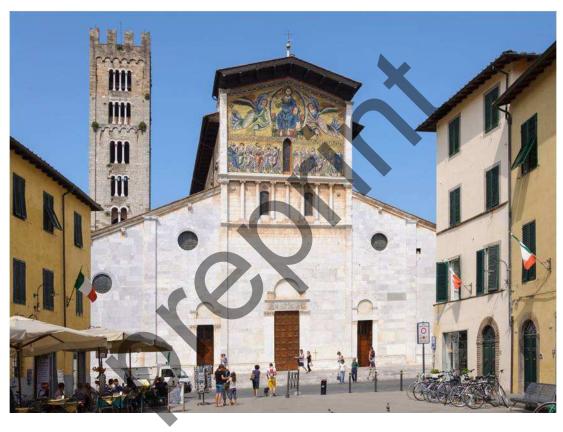
Figure 1: The Basilica of San Frediano in Lucca (Italy). On the left, the San Frediano bell tower.

The Basilica of San Frediano (see Figure 1) dates back to the 11th century. It is one of the most fascinating monuments in Lucca, much of its fascination being due to the marvellous mosaics that adorn its façade, which glistens spectacularly in the light of the rising sun. The church's bell tower is one of the best preserved in Lucca's historic centre. It is 52 m high, with walls

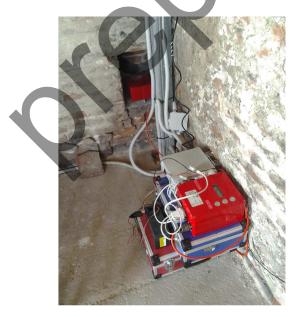
Figure 3: A seismic station on the San Frediano bell tower.

Between May and June 2015 the tower was instrumented with four SARA triaxial seismometric stations (Figure 3). Each station was equipped with a SL06 24-bit digitizer coupled to a SS20 seismometer (electrodynamic velocity transducer). The instruments, made available by the Osservatorio Sismologico of Arezzo (INGV) are usually employed in seismic monitoring networks. They were arranged on the San Frediano bell tower along a vertical line, as shown in Layout 1 of Figure 4, and left active on the tower for five days. The results of this experiment are available in [1]. Subsequently, the instruments were installed again on the tower and left active from 28 October 2015 to 16 October 2016. Over the course of this year, two main sensor layouts were chosen. In the first (reported as L_2 in Figure 4), two sensors were placed on two opposite sides of the bell chamber, and the remaining aligned along the tower. In the second (reported as Layout 3 in Figure 4) one of the sensor along the tower's height was moved to the base,
